Field Testing for Curtain Wall Leaks—Case Study

5750 Explorer Drive Office Building

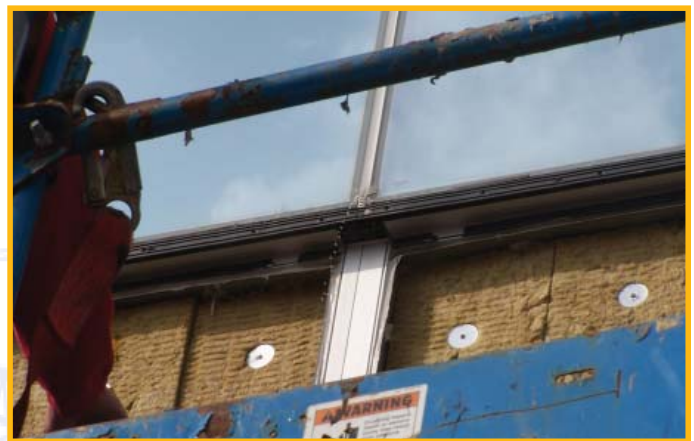
Trapped water escaping when a blocked weep is opened.

system and was visible on the exterior side under a relatively low 30 Pa of applied pressure. Further investigation was deemed necessary where smoke was observed to penetrate the system. Several panels were deglazed— in other words, the caps, pressure plates and seals were systematically removed and inspected before removing the entire panel. Water was found to be collecting between the weather seal and air seal in the vertical channels, and some drainage paths were blocked. Here, as in many such cases, deglazing is essential in order to hunt for defects in the air seal, which is usually hidden deep inside the system.

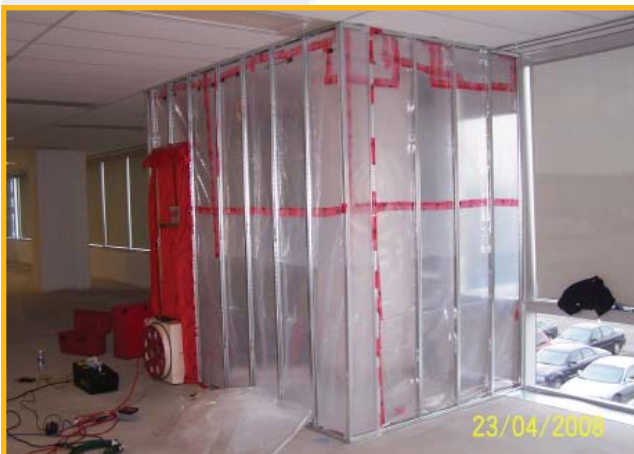
Sealed test chamber on inside of curtain wall.

To help identify the source of the water leaks and confirm the IR expressions, a section of the curtainwall known to be leaky was surrounded on the interior with an airtight stud wall chamber. A smoke generator was placed in the chamber, which was then pressurized with a blower door. At some locations, smoke came through the curtain wall
